**AltaLink transmission line – 1043L (formerly 904L):
Potential hazard warning – spacer damper failure**

As part of our ongoing commitment to safety, AltaLink will be increasing the frequency of its inspections along the 1043L transmission line, formerly called 904L. AltaLink is increasing inspections along 1043L line to monitor the condition of a piece of equipment called a spacer damper. The Métis Nation of Alberta (MNA) was engaged in 2009 regarding the 1043L (904L) Transmission Line Rebuild development. The MNA's members may be conducting Traditional Land Use activities where the 1043L line will require more frequent inspections. We are asking the MNA to communicate to their members the potential safety issue related to the spacer dampers.

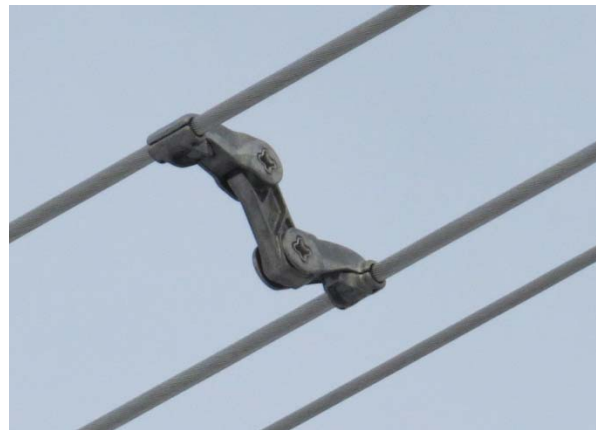
A spacer damper connects two or more wires at intervals between transmission towers to reduce movement in adverse weather conditions by preventing the wires from contacting and damaging each other. Spacer dampers are attached to the wires with clamps and secured by bolts. The picture below is an example of a spacer damper installed on a transmission line.

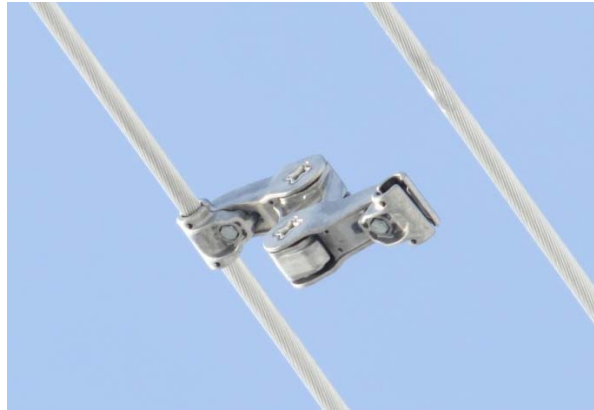
AltaLink is increasing inspections because installed spacer dampers of this type have failed on AltaLink transmission lines. Clamp bolts on the failed spacer damper did not remain secure and the clamp released from the wire, causing a portion of the spacer damper to fall to the ground. The picture below is an example of a spacer damper in a failed condition.

AltaLink will be inspecting spacer dampers on an ongoing basis and will address any issues as required. Inspection activities on Crown lands may include low-level helicopter flight inspections, ground level inspections and crews accessing the line from service trucks.
