**AltaLink transmission line – 1054L and 1206L/1212L (Heartland Transmission Project):
Potential hazard warning – spacer damper failure**

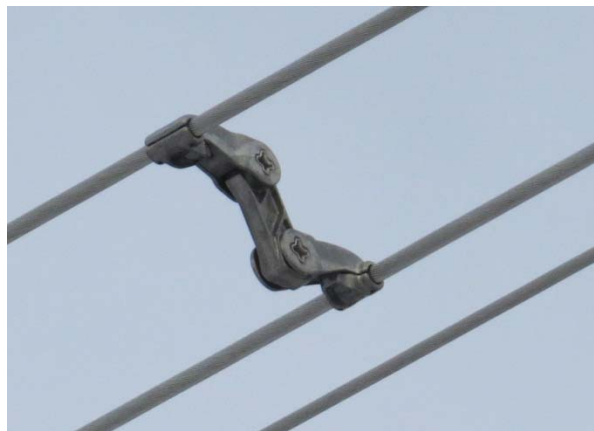
A spacer damper connects two or more wires at intervals between transmission towers to reduce movement in adverse weather conditions by preventing the wires from contacting and damaging each other. Spacer dampers are attached to the wires with clamps and secured by bolts. The picture below is an example of a spacer damper installed on a transmission line.

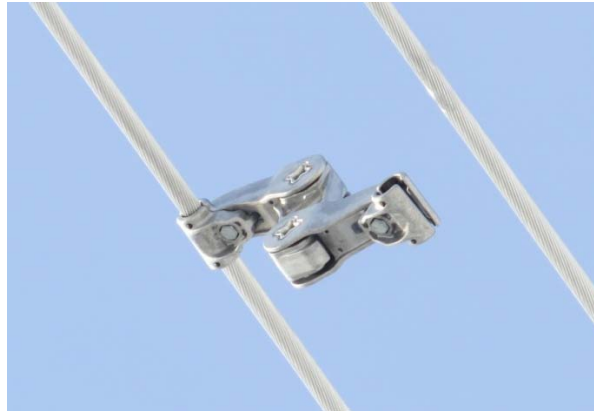
AltaLink is increasing inspections because installed spacer dampers of this type have failed on AltaLink transmission lines. Clamp bolts on the failed spacer damper did not remain secure and the clamp released from the wire, causing a portion of the spacer damper to fall to the ground. The picture below is an example of a spacer damper in a failed condition.

AltaLink will be inspecting spacer dampers on an ongoing basis and will address any issues as required. Inspection activities on Crown lands may include low-level helicopter flight inspections, ground level inspections and crews accessing the line from service trucks.

If the MNA members believe they have found pieces of spacer dampers on the ground, or notice a spacer damper that appears to be in the failed position outlined and shown above, please contact AltaLink at 1-877-380-0303 or landowner.advocate@altalink.ca and AltaLink will conduct further inspection and investigation.

Please do not pick up or move the pieces because seeing them in their original location will allow AltaLink to more easily identify the line section from which the spacer damper fell.

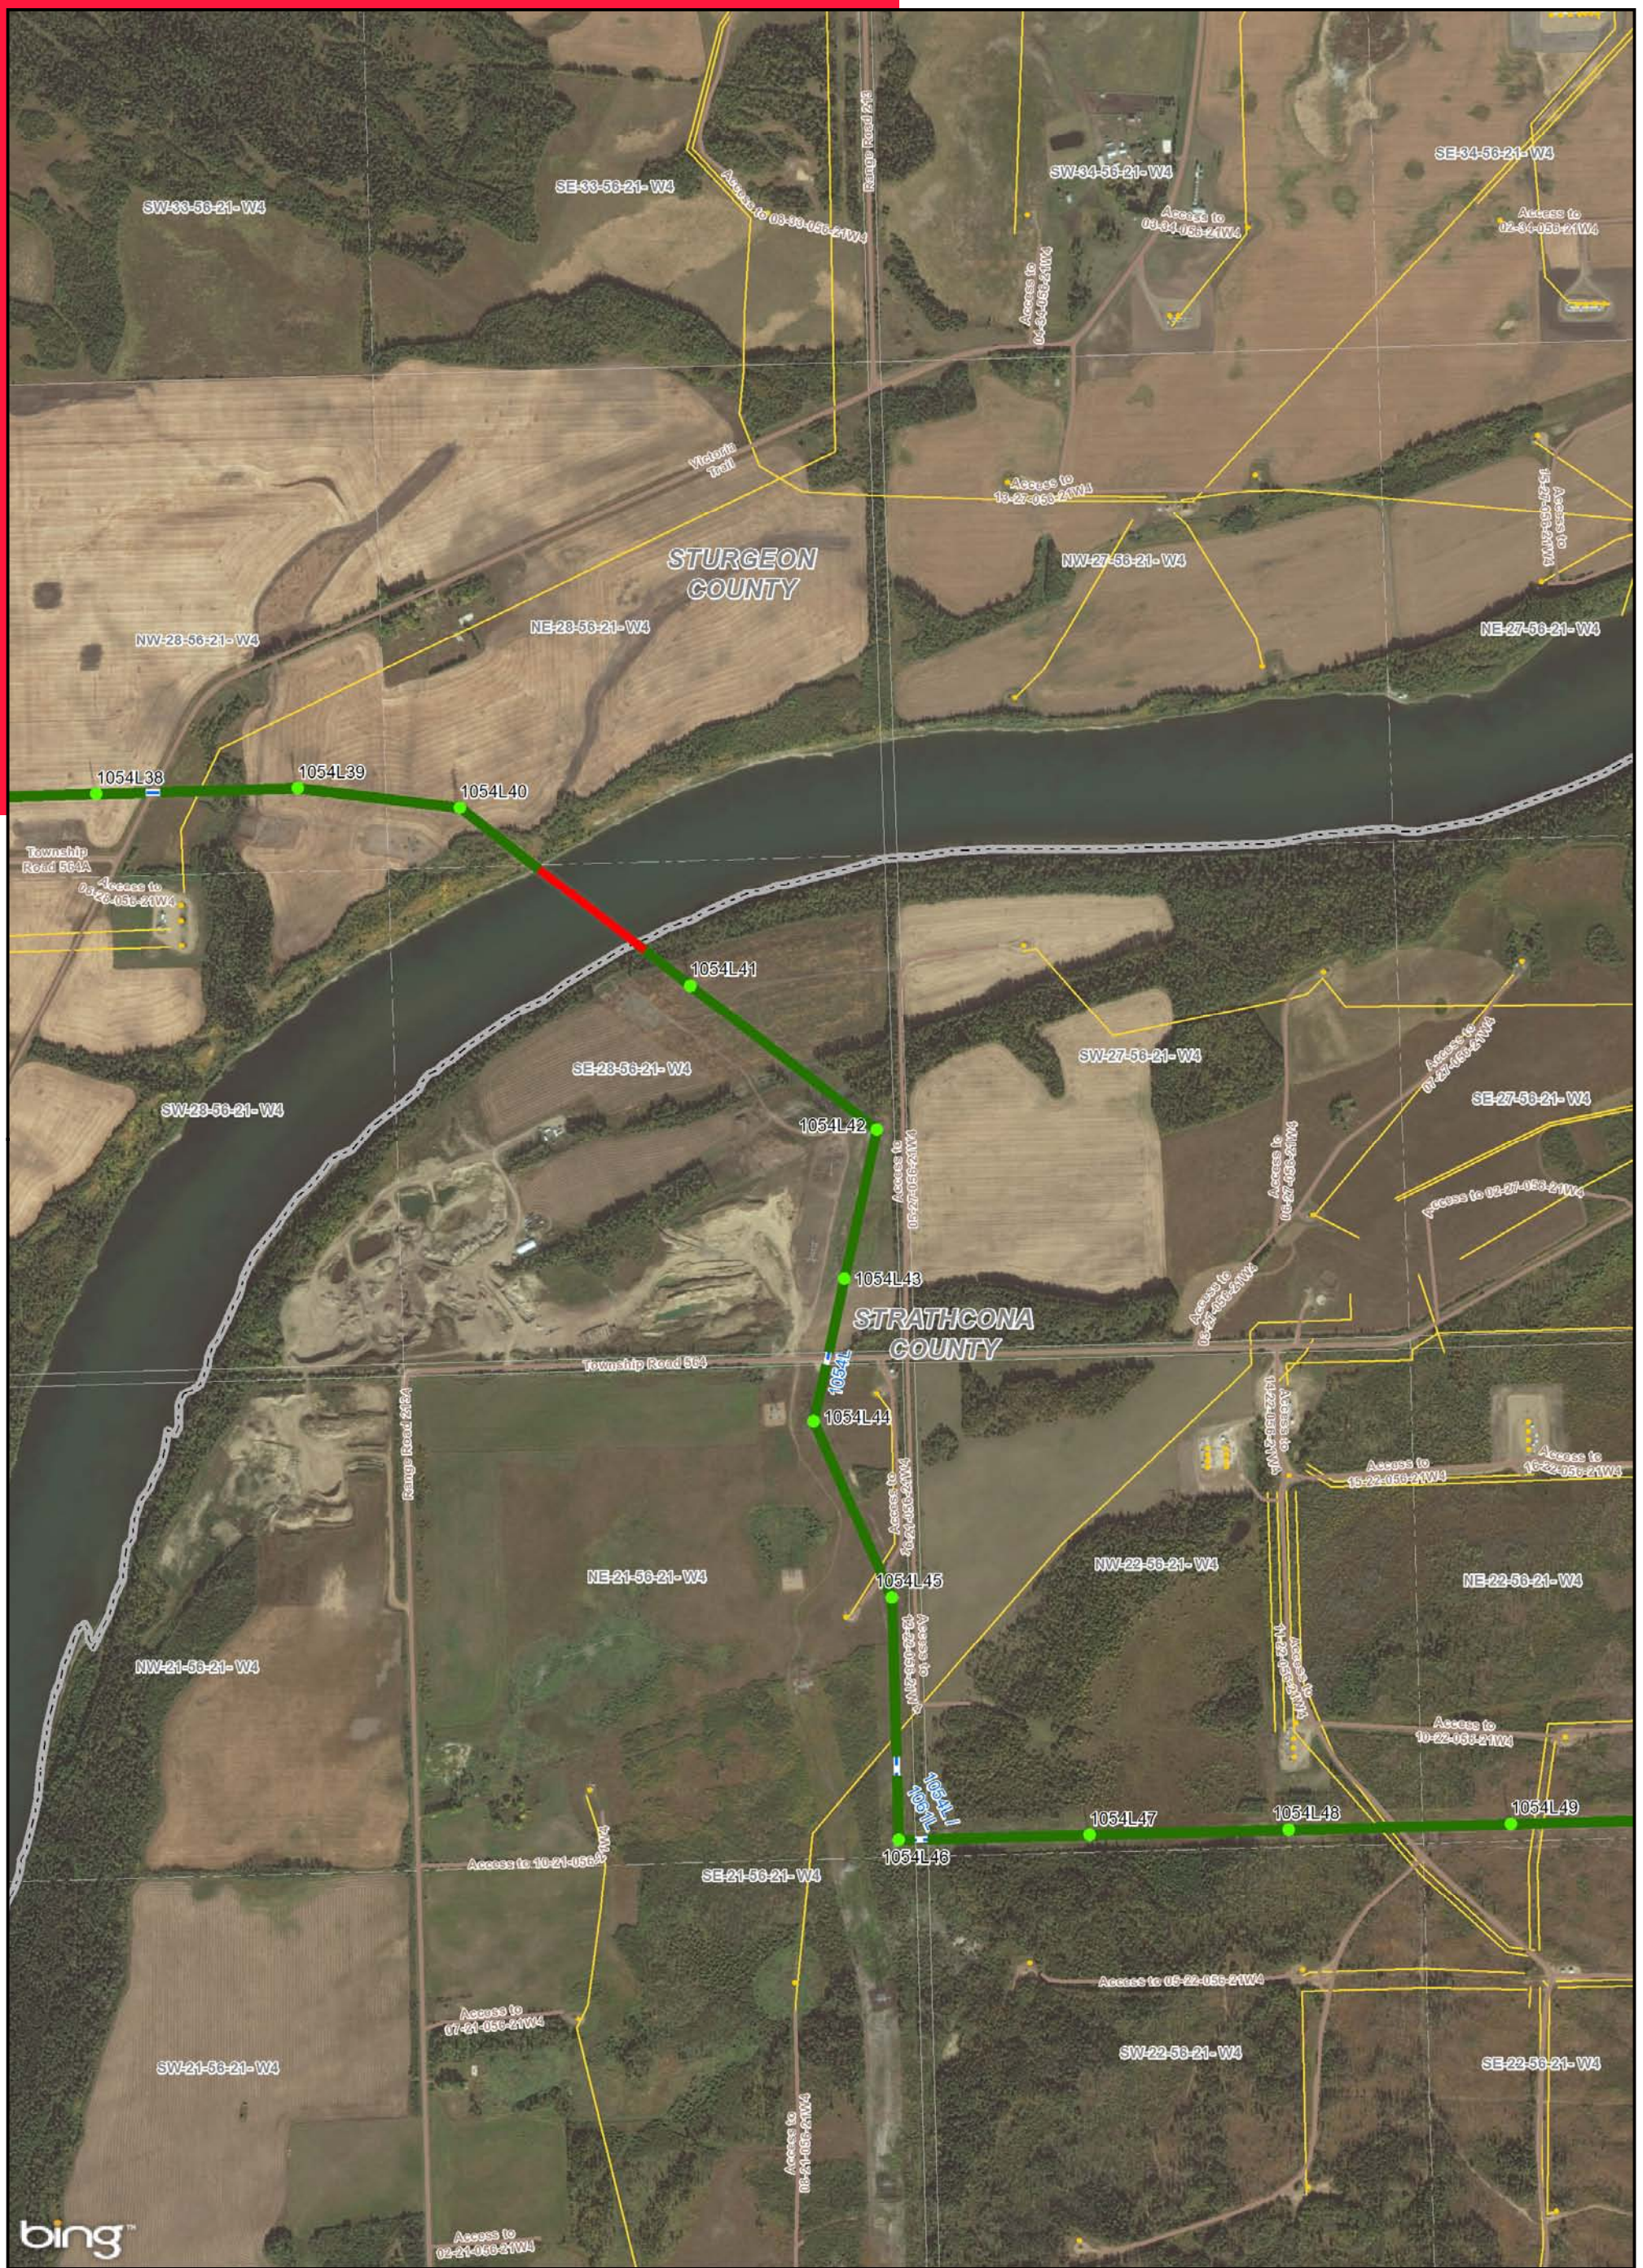
STRIP MOSAIC SM5

- SE-28-56-21-W4 (SM5)
- NE-28-56-21-W4 (SM5)
- SE-32-55-22-W4 (SM17)
- NE-29-53-23-W4 (SM9)
- SE-29-53-23-W4 (SM9)

If circumstances are such that you must cross and/or walk along the right-of-way, please avoid crossing under and walking in areas below the spacer dampers.
