September 6, 2016

AltaLink transmission lines: Spacer damper replacement

Inspection and replacement update:

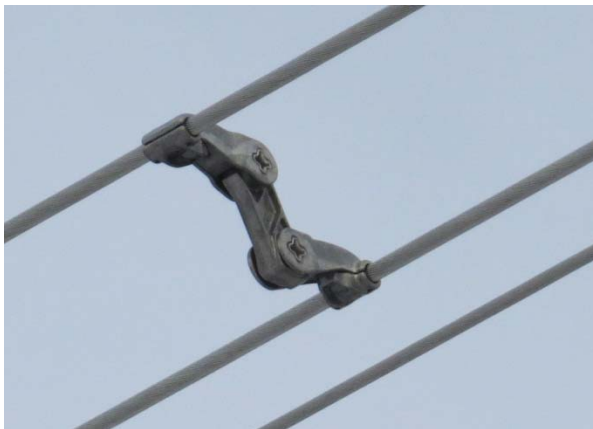
Spacer damper installed on transmission line

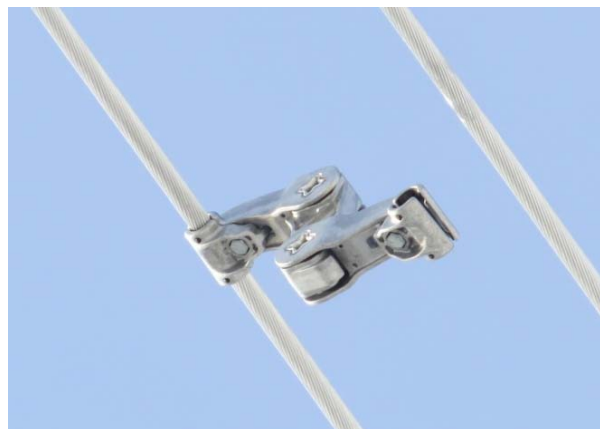
A spacer damper connects two wires at intervals between transmission towers to reduce movement in adverse weather conditions by preventing the two wires from contacting and damaging each other. Spacer dampers are attached to the two wires with clamps and secured by bolts. Clamp bolts on the failed spacer damper did not remain secure and the clamp released from the wire, causing a portion of the spacer damper to fall to the ground.

Spacer damper in a failed position

All spacer dampers of this type will be replaced. Replacement is expected to begin in October 2016 and we anticipate the work will be completed by June 2017.
